ENGINEERING CASE LIBRARY

THE (Delinquent) DRAWBAR (A)

A study of the circumstances surrounding an accident involving a tank train hauling gasoline. The train overturned on an exit ramp from an interstate highway, caught fire and burned, completely destroying the tank train and cargo. A key question was whether the drawbar between the semi-trailer and full trailer broke after the start of the accident or whether it broke before the accident and thus was the initiating cause.

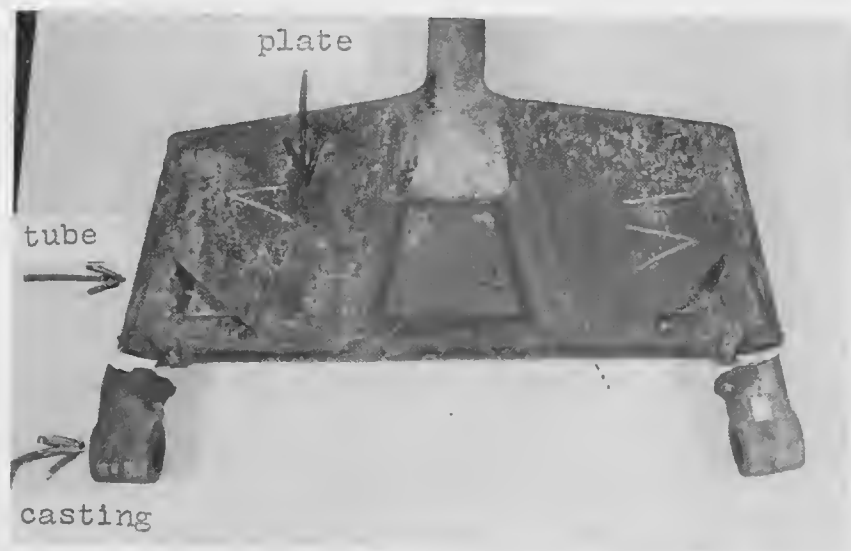
A metallurgist (Mr. B), retained by the plaintiff, found that the drawbar was built-up of tube, plate, and castings welded together as shown in Fig. 2. The steel casting in the vicinity of the fracture had a ferritic matrix with a fine lamellar pearlite. The tube was a low carbon steel having pearlite in a ferrite matrix. These were reasonable structures. Considerable recrystallization was observed at the weld interface and through the heat-affected regions.

Fig. 2: Overall view of drawbar showing the component plates, tubes, and castings welded together. The two failed castings are shown in approximately their respective locations.

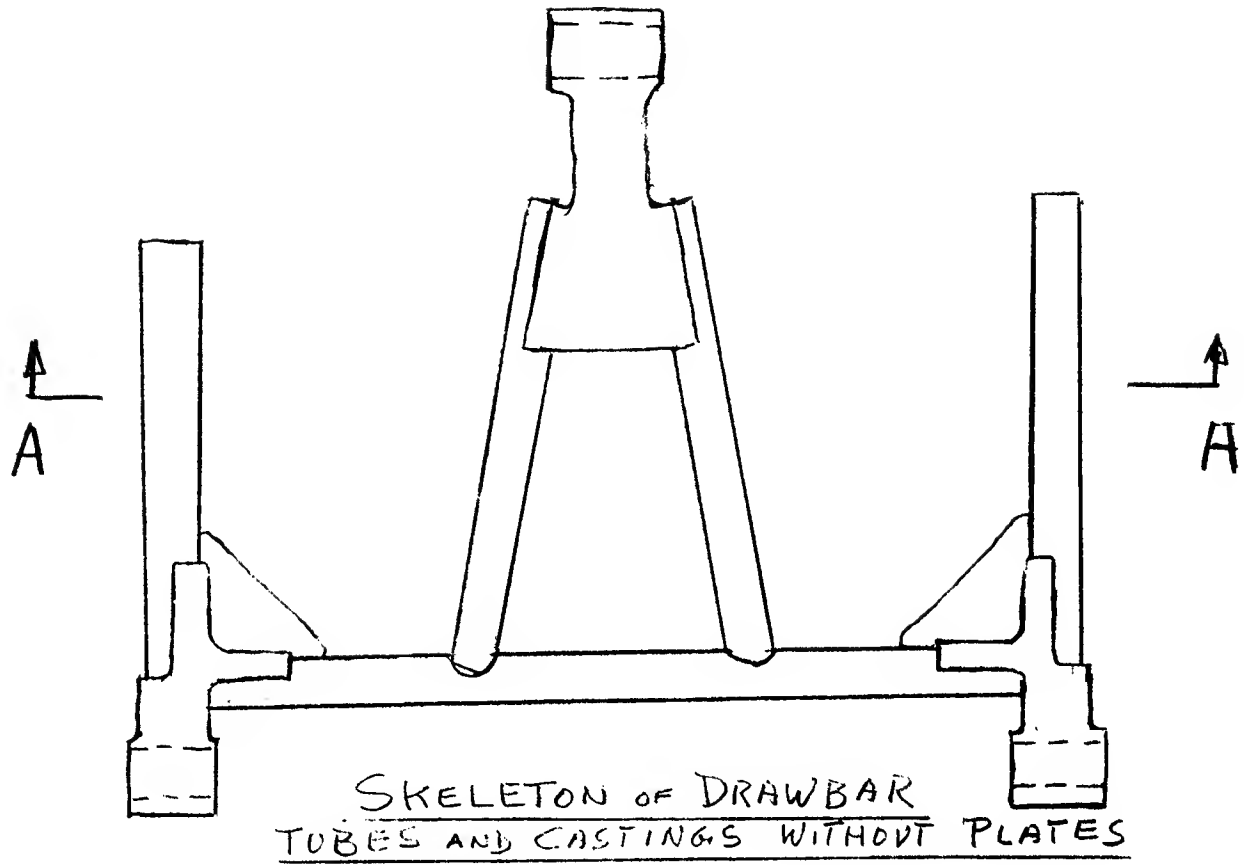
Fig. 2a

Editor's sketch of the configuration of the drawbar.

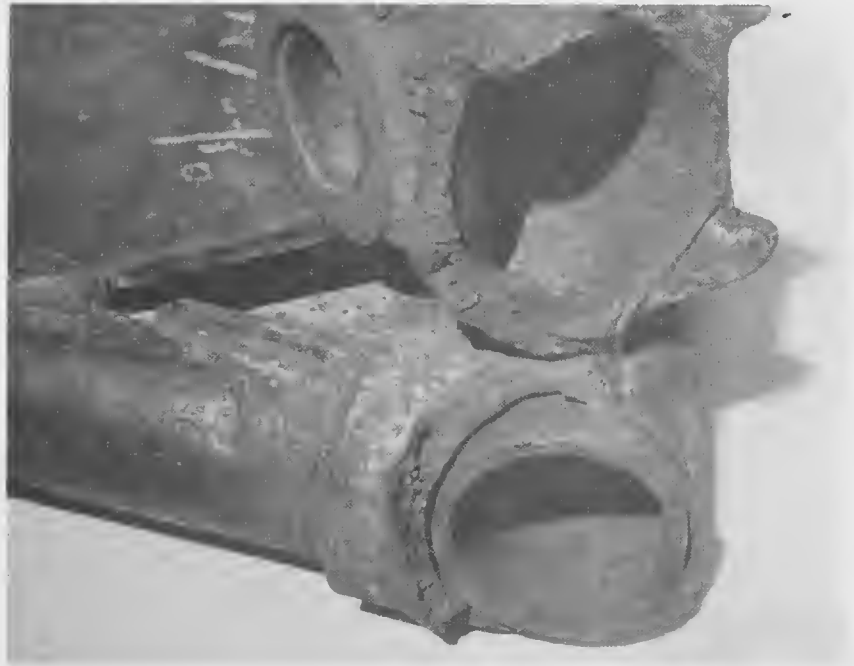
Figure 3 is a close-up view of the two fracture surfaces at the right side of Fig. 2. Figure 4 is a still closer view of the fracture surface of the casting (lug). The break is through the weld between tube and casting (top of Figure 4) and through the casting (bottom of Fig. 4). The casting was of poor quality as rather large pores (or shrinks) are obvious at the bottom of Fig. 4. There was also evidence of further porosity but with smaller size pores. It was doubtful that the manufacturer had x-rayed these castings before assembly since voids of this size would certainly have been detected. He should have been conscious however, of possible questionable quality since there had been some surface welding repair work on both of the castings.

Fig. 3: Fracture on right side of Fig. 2 at the joint between the tube and casting. Broken casting is placed on top to show matching of the two halves.

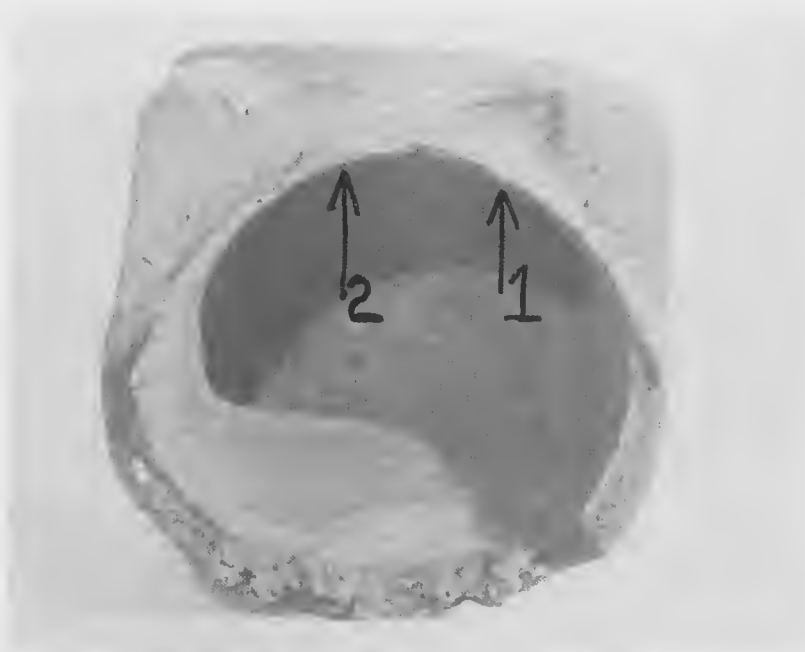
Fig. 4: View of fracture surface of casting from right side of Fig. 2. Weld is at top. Extensive voids and porosity are visible at bottom.

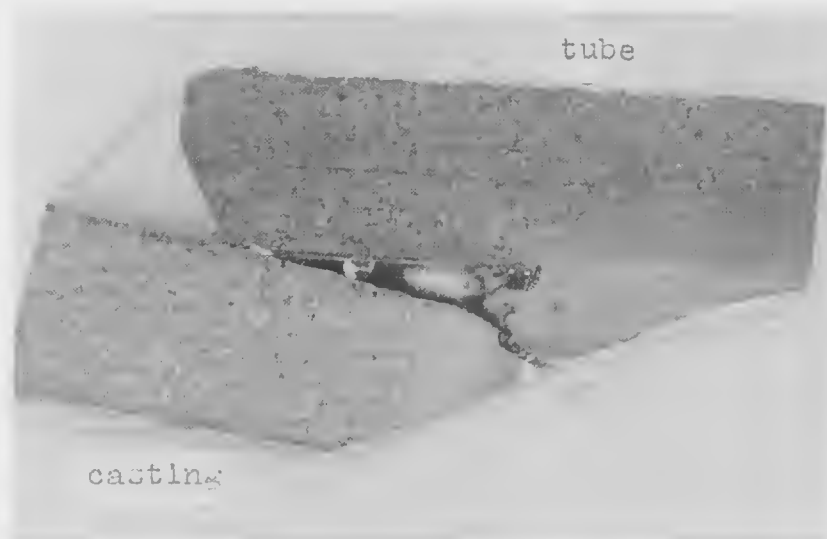
A section through the weld between tube and casting is shown in Fig. 5. Fig. 6 shows an enlargement of a portion of this weld. Fig. 5 shows the heat-affected zones and lack of penetration of the weld. The lack of penetration is still more evident in Fig. 6.

Fig. 5: Section of joint between tube and casting, showing weld deposit, heat affected zones and low weld penetration. 2% Nital etch. 4.5 X

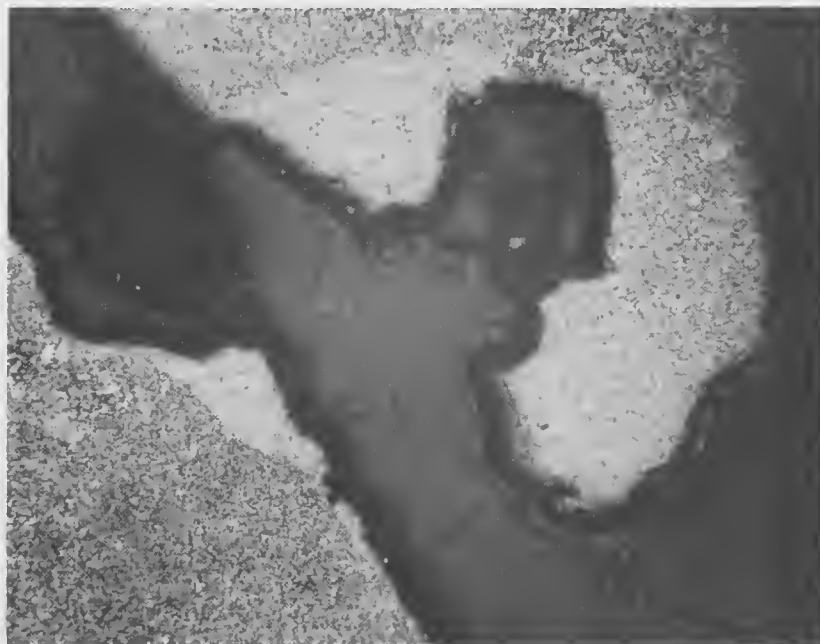
Mr. B. concluded that both the castings and the welding were inferior and thus the basic cause of failure in the drawbar was poor quality workmanship. He believed that the failure started at the weld between the tube and casting. Despite Mr. A.'s comments on progressive failure (indicating a fatigue failure), he could find no evidence on visual examination which conclusively supported this view.

Fig. 6: Portion of the joint shown in Fig. 5 between casting and tube at the weld showing poor weld penetration. 2% Nital etch. 50 X

Following the accident, improved welding procedures and inspection procedures were instituted. The chief engineer had testified at the trial that there were no inspection procedures at the time of manufacture as there had been complete reliance on the reputation of the foundry which made the castings.

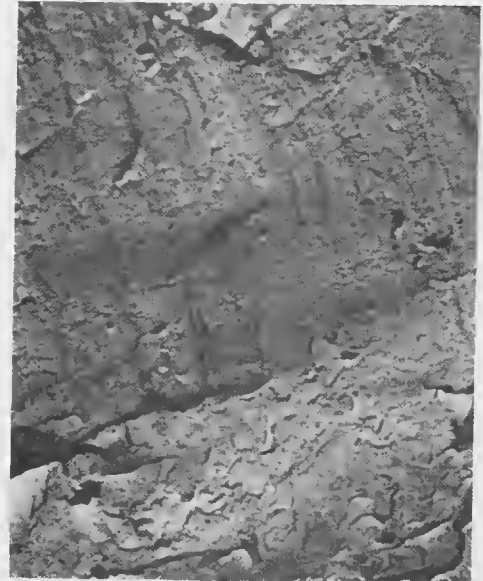
Mr. B. then conducted an examination of both broken castings using electron microscopy. Much of the fracture surface through the weld was examined. Figure 7 shows a portion of this surface in the position indicated by arrow 1 (Fig. 4). "Parallel" striations are clearly visible. These striations are characteristic of fatigue failure (progressive failure) since the striations show the advance of a crack front from one cycle of loading to the next. Figure 8 shows a typical portion of the fracture surface in the position indicated by arrow 2 (Fig. 4). The black dots are due to corrosion products. This indicates failure in this region well in advance of the final failure.

Fig. 7:
Region of fracture surface
in weld at location shown
by arrow 1 in Fig. 4. The
striations in the figure
indicate a progressive or
fatigue failure as the
lines represent the move-
ment of the crack front
under successive load ap-
plications.

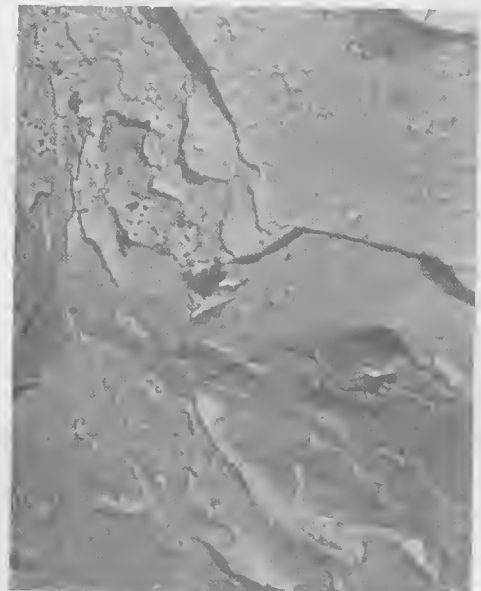
Figure 9 is representative of the fracture surface of the left casting. This is a typical cleavage failure. No evidence was found of fatigue striations or corrosion. This does not say, however, that none existed in the left hand casting.

Fig. 9:
Region of fracture surface
in weld in left hand cast-
ing. This is a typical
fracture surface which
failed by cleavage in a
brittle manner. It is
representative of the left
hand casting.
